Inspection Notes of C.D.Kumar, CEO-KSPCB

Name of The HCE visited	M/s John Mines of R.Praveen Chandra ML No.2294, D.Medikeripura, Sirigere Post, Chitradurga Taluk
Date of Visit	06.03.2020
Officers Accompanied	Muralidhar-SEO, E. Prakash – RO, Lohit Kumar-DEO
Person Contacted	Deepak, Manager-Geology Ajith, Manager-Environment

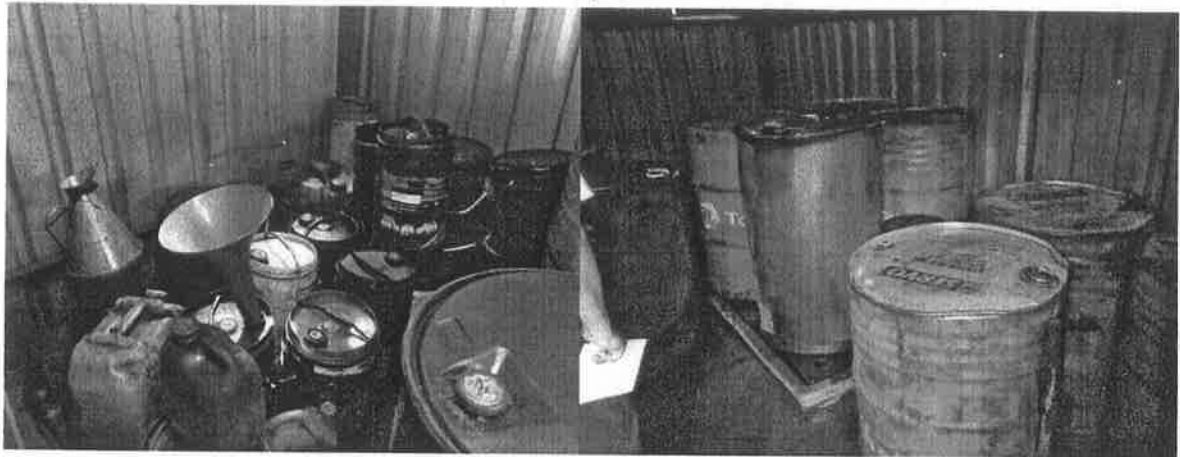
- The Board has granted Authorisation for the period up to 30.06.2021 to handle only Used spent Oil however the occupier is also handling wastes containing oil. The Occupier has provided separate shed for storage of haz wastes. On verification of records it is noticed that the occupier is disposing wastes to M/s Mahalakshmi Industries, Tumakuru. About 500 lts of used oil and 15 no's of oil filters storage noticed. The floor is damaged and it requires handing improvement to make completely impervious. Besides better spillage management facility with catch pit is to be established.

Hazardous waste storage facility

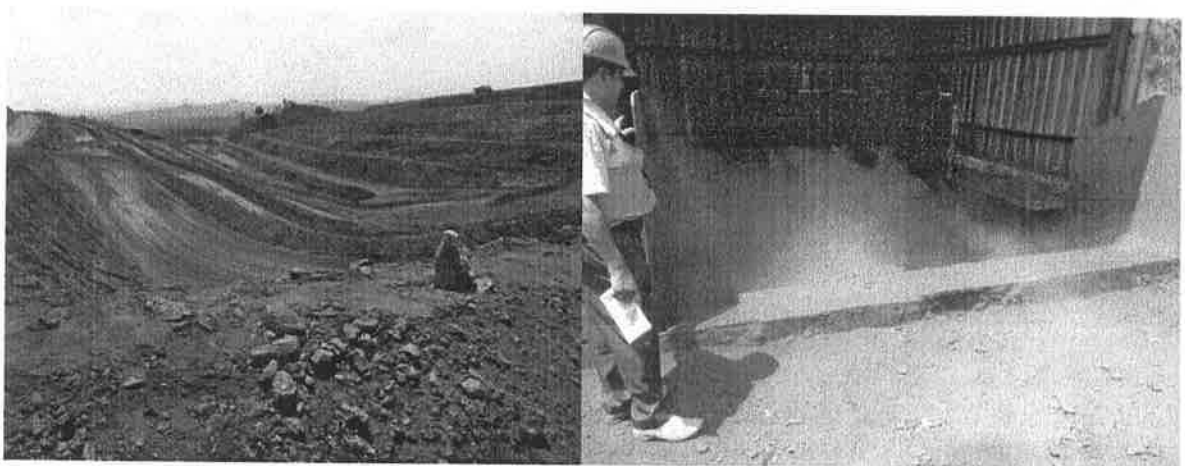
- The Board has granted consent for iron ore mining as per CEC concurrence dated 18.03.2016 for the period up to 30.06.2021. During visit no mining activity (extraction of ore from mining pit) noticed and to query the representatives informed that they have already extracted permitted quantity of ore for the period 2019-20 and stopped mining activity. The RO was instructed to secure production details and to cross verify with Dept of Mines & Geology.

Mining Pit

Water fog at Crusher Loading Point

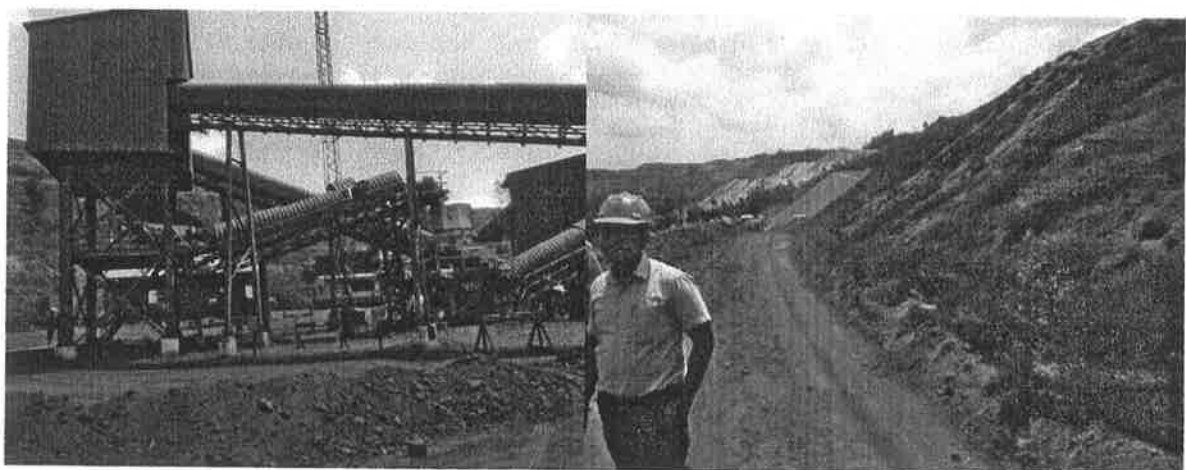
- Mobile Health Clinic and First Aid station exists in mining area for which the occupier has not obtained Authorisation under BMW Rules 2016.
- The mining authority is having Fixed Crushing cum Screening units of 250 TPH capacity comprising of jaw crusher, cone crusher, two screens and 8 conveyor belts. The unit was not in operation during visit. Responding to a query the Manager informed that the crusher is not in operation since end of January 2020. No effective dust control systems provided at crusher loading section (from trucks) except symbolic water fog system. In addition one fixed and two mobile Screening units existing. Adequate dust control equipments not provided for these units except for water sprinkling arrangement. The authorities have to take immediate measures to provide suitable and efficient APC measures for these units.

Ore Crushing cum Screening Unit

Ore Dump with stabilisation
