Inspection Notes of C.D.Kumar, CEO-KSPCB

| Name of The HCE visited | M/s Kanchipura Lime Stone Mine, owned by M/s Ramco Cements Ltd, ML No.2643, Kanchipura, Hosadurga Taluk, Chitradurga District |
| Date of Visit | 05.03.2020 |

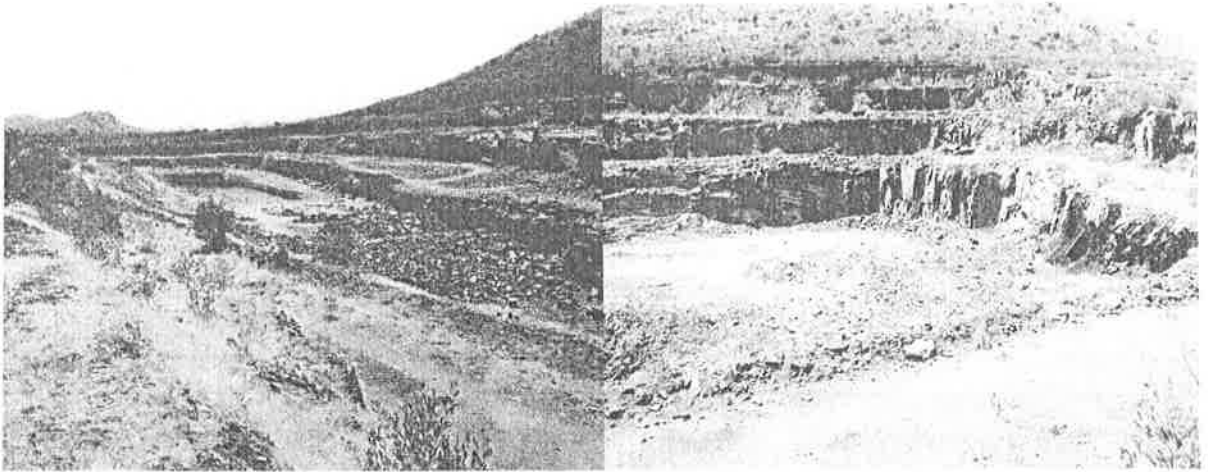
Mining Pit

- Two mining pits exist in mining area and no mining activity noticed in both the pits. During discussions the Mines Manager informed that one pit having dimension of about 450X100X20 Mts is closed during 2010 and in another pit of about 350X150X20 Mts closed during 2018. Stagnation of water noticed.
- The occupier has not taken up afforestation along the boundary of the mine area besides for stabilization of dumps to prevent soil erosion.
- The overburden is dumped haphazardly instead of scientific deposition as per IBM approved plan besides not constructed adequate retaining wall along the dumps. Also not provided with storm water drains/trenches to prevent runoff.
- The occupier has not fenced the mining pits to prevent unauthorized entry.
- Rain water harvesting and ground water recharge measures viz check dams, gully plugs etc are not provided.
