No.PCB/SEO-CTA-67/Random-IR/2019/

Inspection Notes of C.D.Kumar, SEO, Chitradurga

Name of The Industry visited	M/s Shiva Enterprises, Plot #311-A, 2 nd Phase, KIADB Ind Area, Harohalli, Kanakapura Taluk, Ramanagara District
Date of Visit	30.08.2019
Officers Accompanied	Lokesh, DEO
Person Contacted	Sathish, Partner

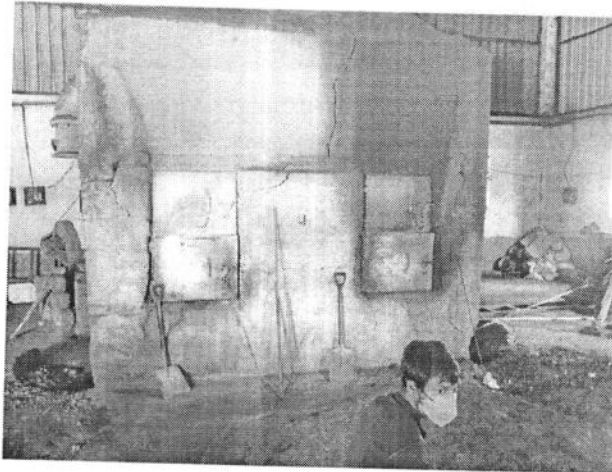
Charcoal Bhatti

- Charcoal fired Bhatti is having two crucible (one working at the time of visit) is provided with dust collector, cyclone and bag filter followed by a chimney of 30 AGL height. No Rotary Furnace installed. In addition a small HSD fired Pot Furnace is installed and for process emissions emanating from this furnace no APC measures are provided. During discussions the Partner informed that presently they don't have any plan to install Rotary Kiln due to poor market condition.

- For 62.5 KVA DG set required APC measures are not provided. Fugitive emissions noticed while collecting lead ash from cyclone & Bag filter into drum. Instructions given to improve collection system to avoid fugitive emissions.

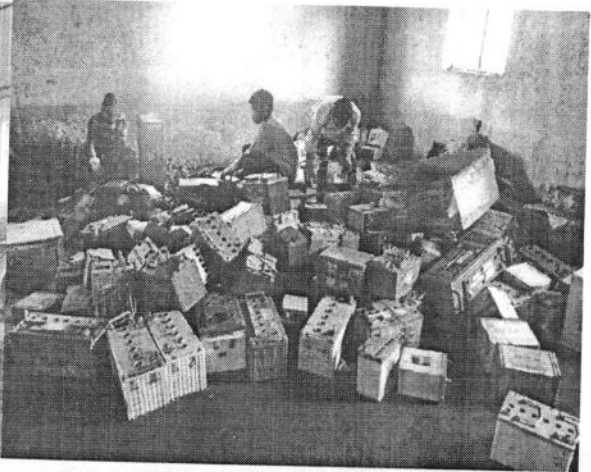
Manual Dismantling

- The used lead acid batteries of different sizes received at site are dismantled manually and lead bearing components are fed into charcoal fired Bhatti having two crucibles to recover lead in molten form which is subsequently fed into moulds to produce lead ingots. No acid proof flooring provided for storage of used batteries, dismantling activity and segregation of dismantled parts. No acid collection system in place for drained acid from used batteries. During discussions the Partner informed that they are procuring only acid drained old batteries and as such acid collection system not required. The DEO was instructed to verify the claim.

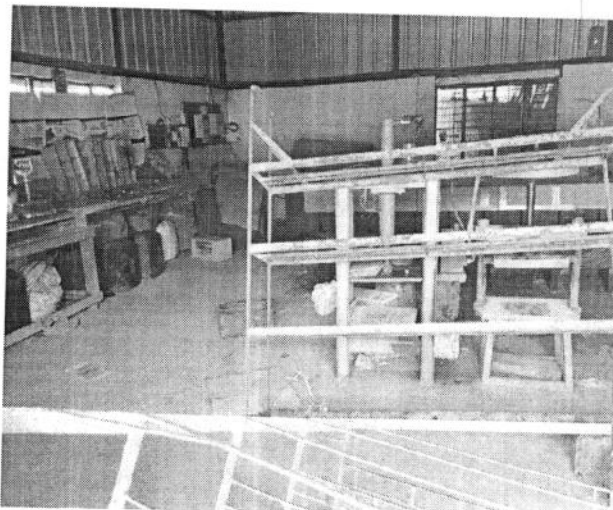
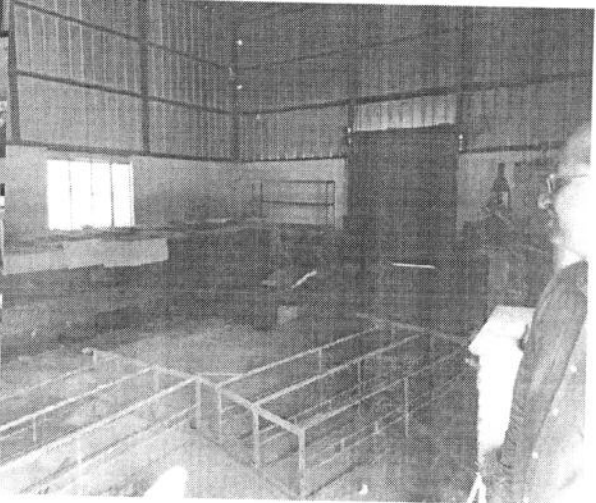
- The Battery manufacturing activity is not in operation during visit and to query the Partner informed that they have discontinued battery manufacturing activity long back and planned to sell/dispose the plant & machinery pertaining to this activity.

- Closed Battery Manufacturing Unit

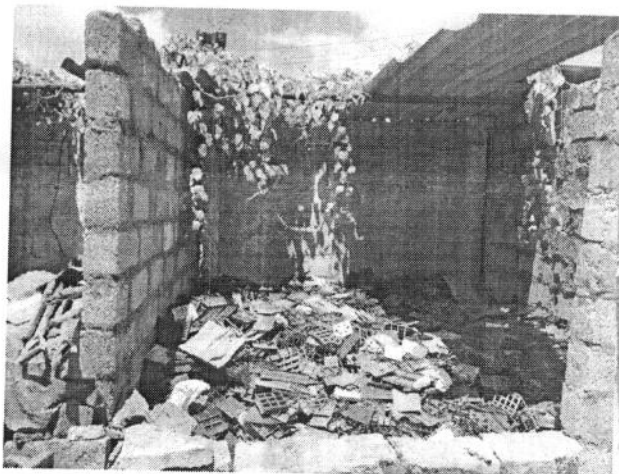
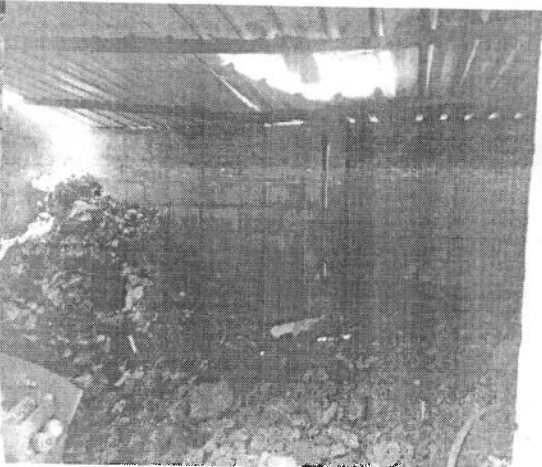
- Separate rooms are provided to store dismantled non-lead components, slag and ash collected in APC equipments. The roof provided for this storage facility is damaged/collapsed at few places. Instruction was given to the Partner to rectify the same immediately to avoid rain water entry besides to improve the secured storage facility.

Damaged/Collapsed Roof of slag, ash & Dismantled components
