Inspection Notes of C.D.Kumar, CEO-KSPCB

Name of The HCE visited	M/s Mathod Lime Stone Mine, owned by M/s Ramco Cements Ltd, ML No.2342, Mathod Village, Hosadurga Taluk, Chitradurga District
Date of Visit	05.03.2020
Officers Accompanied	Muralidhar-SEO, E. Prakash – RO, Lohit Kumar-DEO
Person Contacted	Victor, Jr Mines Manager

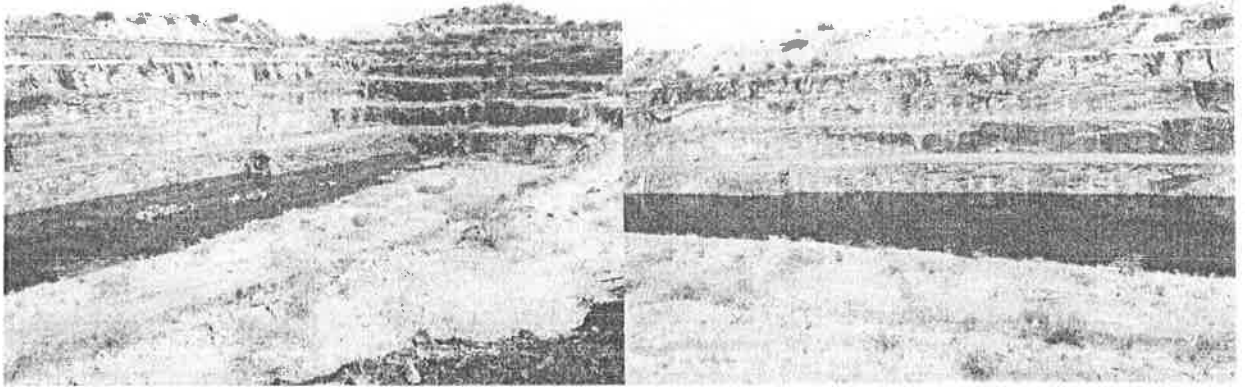
- No mining activity noticed in mining pit. During discussions the Mines Manager informed that pit having dimension of about 280X140X20 Mts is closed during October 2018. Stagnation of water in the pit noticed.
- The occupier has not taken up afforestation along the boundary of the mine area besides for stabilization of dumps to prevent soil erosion.
- The overburden is dumped haphazardly along road side instead of scientific deposition as per IBM approved plan besides not constructed adequate retaining wall along the dumps. Also not provided with storm water drains/trenches to prevent runoff.
- The occupier has not fenced the mining pits to prevent unauthorized entry.
- Rain water harvesting and ground water recharge measures viz check dams, gully plugs etc are not provided.

Mining Pit

The observations made during visit indicate that the occupier has not taken pollution control measures as stipulated in the consent and also to prevent air pollution. The Regional officer was instructed to issue notice immediately based on the observations and to take necessary follow up action as contemplated under law. Besides to secure production details from Local Mines & Geology Department to ensure closure of the mine and also to cross verify the monitoring activity. The photographs taken during visit are enclosed.

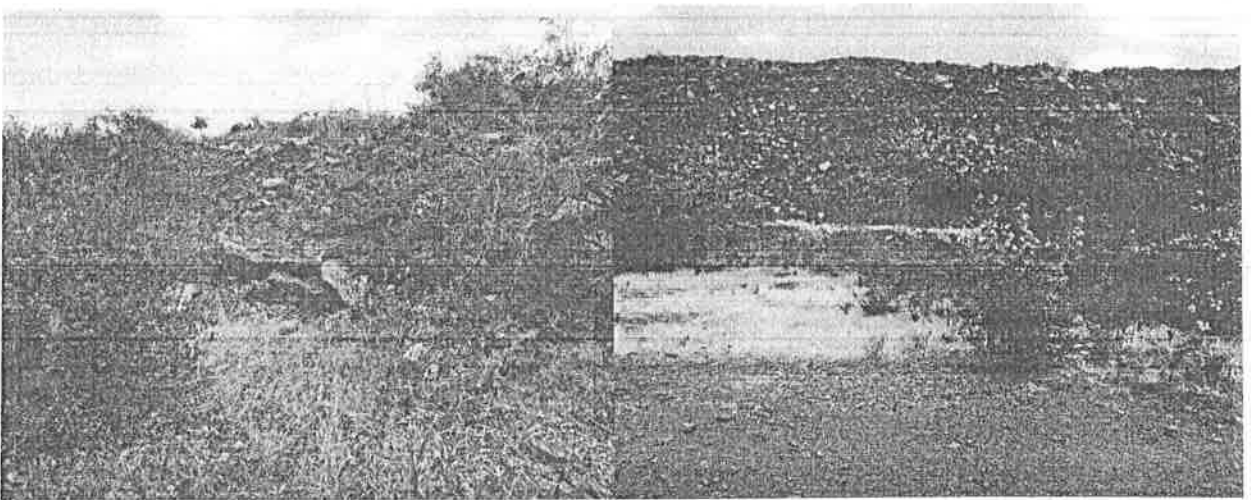
Overburden Dump
