Inspection Notes of C.D.Kumar, CEO-KSPCB

Name of The HCE visited	M/s Vedanta Limited, (formerly M/s Sesa Goa Ltd), ML No.2677, Megalahalli, Chitradurga Taluk
Date of Visit	06.03.2020
Officers Accompanied	Muralidhar-SEO, E. Prakash – RO, Lohit Kumar-DEO
Person Contacted	Madesha, Manager Adithya, Env Engineer

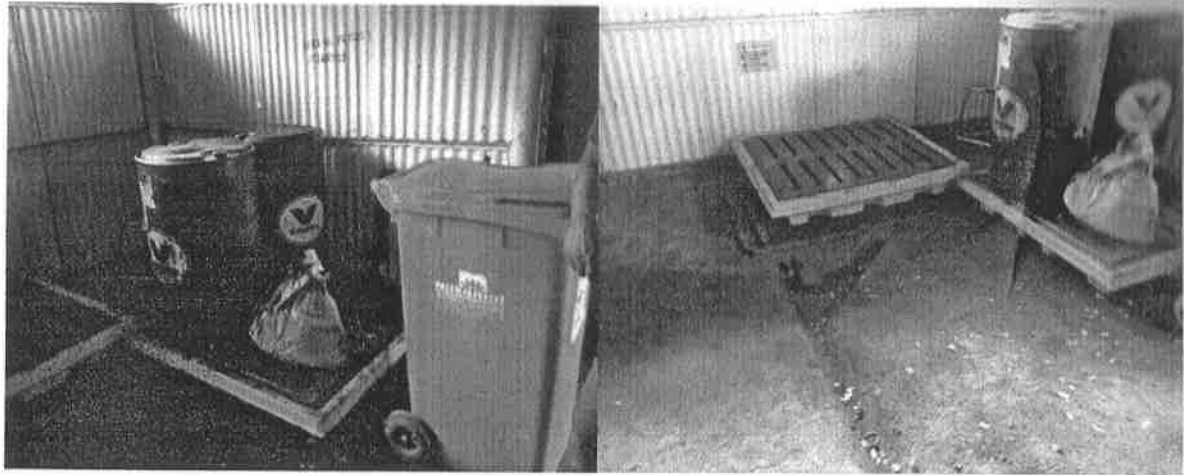
Hazardous waste storage facility

- The Board has granted Authorisation to handle Used Oil & waste residues containing oil. The main source of HW generation is Garage where maintenance of dumpers, excavators, trucks & mining equipments being carried out. The mining authority has constructed separate shed for storage of haz wastes. The used oil & oil filters are stored in MS barrels and for waste cotton PVC container provided. The floor is damaged and it requires improvement to make completely impervious. Besides better spillage management facility is to be established.

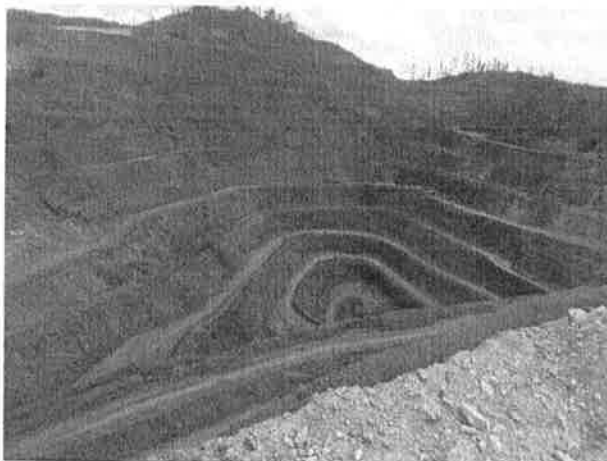
- The Board has granted consent for iron ore mining of 4.51 MMTPA based on CEC letter dated 05.03.2018 for the period up to 30.06.2021. During visit no mining activity (extraction of ore from mining pit) noticed and to query the representatives informed that they have extracted permitted quantity of ore for the period 2019-20 and stopped mining activity by end of February 2020. The RO was instructed to secure production details and to cross verify with Dept of Mines & Geology.

Mining Pit

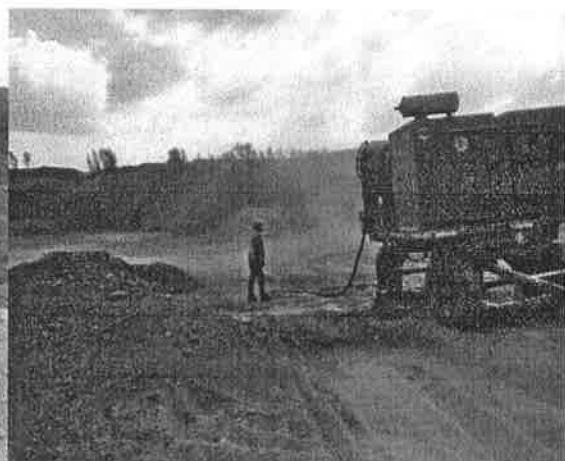
- There are 18 temporary stock yards exist in the mine premises for the storage of graded iron ore. Few are located in cluster and few are in isolated area besides few are below ground level. No efforts made to provide suitable barricade for iron ore stockyards to suppress dust emanated due to wind breeze. These stock yards are not provided with any dust suppression system except symbolic water sprinkling arrangements through tankers. Also these stock yards are not provided with proper arrangements to carry runoff water. The water cannons deployed are grossly inadequate to suppress dust besides symbolic canals stretches are made at few places.

- Permanent water sprinkling arrangements not made at all strategic areas for dust suppression. The present arrangement viz water sprinkling through tankers is inadequate. Besides Plantation has not done all along the internal roads of mining area. During discussions the representatives informed that presently they are in the process of planning for additional plantation which will be taken up during current monsoon.

Water Canon for dust suppression

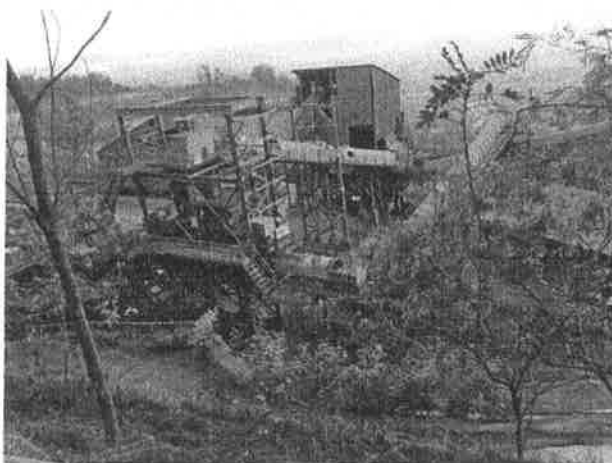
- First Aid station exists in mining area for which the occupier has obtained Authorisation under BMW Rules.
- The mining authority is having one Fixed Crushing cum Screening units of 750 TPH capacity. The unit was not in operation during visit. This crusher is partially covered which is very old and inadequate. No effective dust control system provided at crusher loading section (from trucks). Three Mobile Crushing cum Screening units of capacity 400 TPH are existing. Adequate dust control equipments not provided except for water sprinkling arrangement which is inadequate. In addition there are three Mobile Screening unit of 250TPH for which no APC measures provided. During discussions the representatives informed that the Mist canons are deployed for the purpose which appears to be symbolic. Even though they claimed to be mobile these units are stationed at single points for several months. The authorities have to take immediate measures to provide suitable and efficient APC measures for these units.

Ore Crushing cum Screening Unit

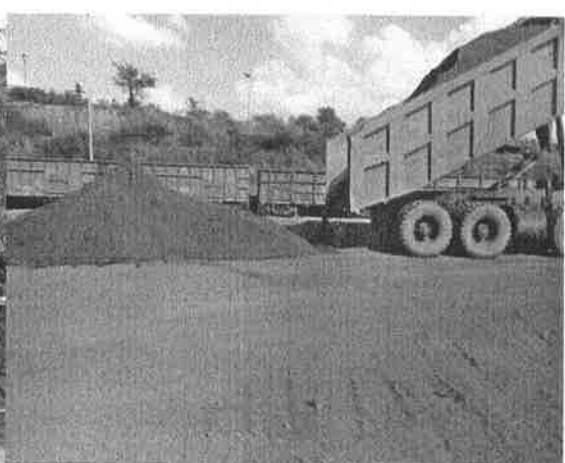
- Required APC measures are not provided at Railway sliding facility where iron ore is stored and loaded to wagons.
- During discussions the Manager informed that they are carrying out monitoring of AAQM, GW, Noise and submitting environmental quality monitoring reports regularly to RO on quarterly basis. RO was instructed to cross verify the monitoring results.

Ore Dump at Railway Sliding Facility
